# Manhole Inspection Summary

Manhole # S25G\_\_021MH

Insp Date: **4/1/08 3:25 PM**

**Location** Address: **14 CAREY ST**

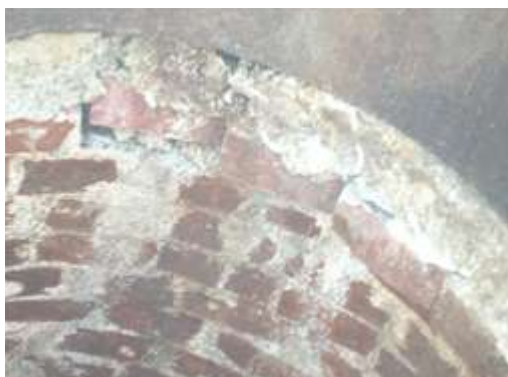
Defect 3

LOOSE CHIMNEY BRICKS

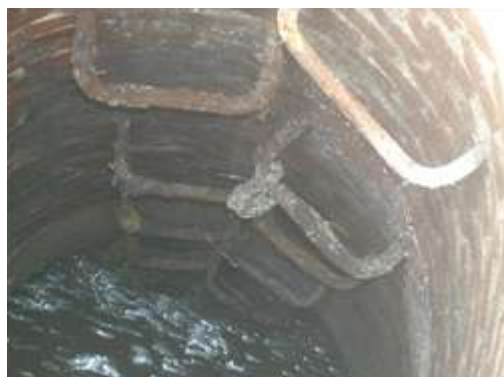
Defect 2

☒ **Evidence Of Surcharge**

Depth: **6** (ft.) ☐ Active Surcharge Present

SURCHARGE EVIDENCE ON STEPS

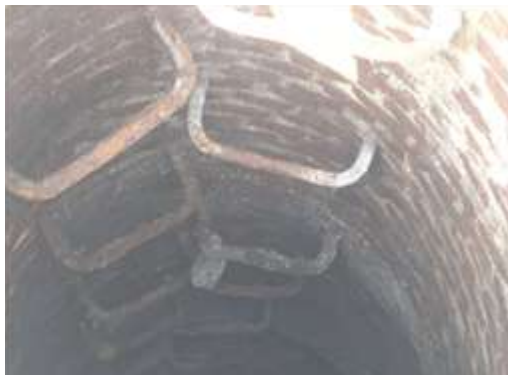
### Defect 1

Count: **12** Missing: **0** ☒ **Corroded**

CORRODED STEPS

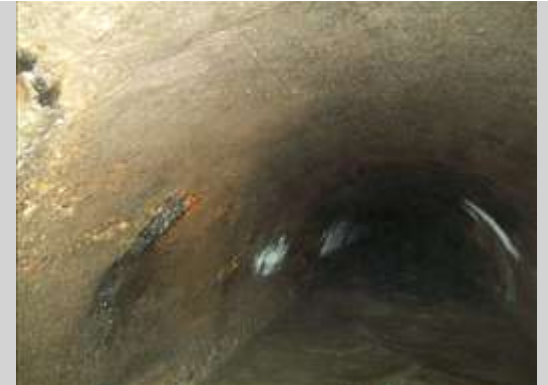
12 O'Clock Outflow

54 in. Circular Gravity Sewer  
Pipe Out @ 12 O'Clock

Pipe Height: **56.4** (in.) Rod and Bar (Angled)  
Pipe Material: **Concrete** ☐ Pipe Lined  
Invert Depth: **17.60** (ft.) Flow Characteristics: **Fast**  
Deposits: ☒ None ☐ Mud ☐ Sludge ☐ Debris ☐ Grease  
Silt Depth: (in.) Deposits Extent:  
Infiltration: **None** Pipe Seal Cond: **Sound**

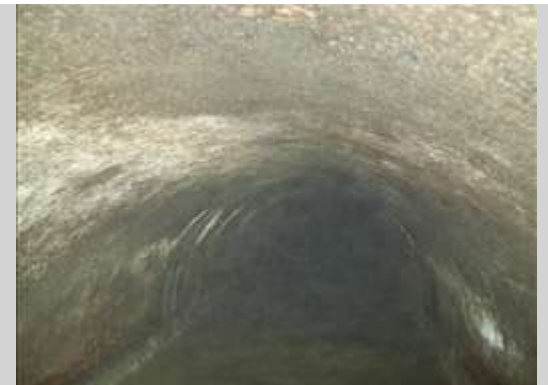
6 O'Clock Inflow

54 in. Circular Gravity Sewer  
Pipe In @ 6 O'Clock

Pipe Height: **54** (in.) Rod and Bar (Angled)  
Pipe Material: **Concrete** ☐ Pipe Lined  
Invert Depth: **17.23** (ft.) Flow Characteristics: **Fast**  
Deposits: ☒ None ☐ Mud ☐ Sludge ☐ Debris ☐ Grease  
Silt Depth: (in.) Deposits Extent:  
Infiltration: **None** Pipe Seal Cond: **Sound**

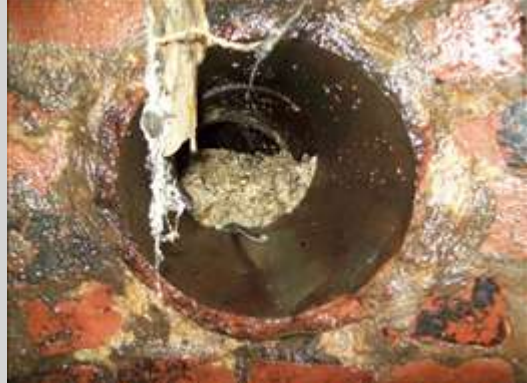
9 O'Clock Inflow

Deposits: ☐ None ☐ Mud ☒ **Sludge** ☒ **Debris** ☐ Grease

Silt Depth: **2** (in.) Deposits Extent: **Medium**
